MEMORANDUM State of Alaska

SUBJECT: Solid Waste Permit
 Number 0111-BA001
 Kennecott Greens Creek
 Mining Company
 November 4, 2002 Inspection
 of Potential ARD Sites
 Not Covered By Permit

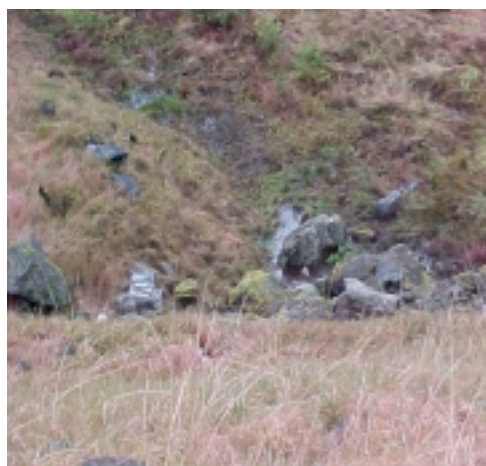
Site “C” Panorama of Downgradient Aspect – Note Proximity of Greens Creek

This 2-acre site is located approximately 100 yards down the B-Road from the mill where the mine safety building and laboratory are situated. Waste rock was placed here over 10 years ago. Approximately 28,400 cubic yards of production rock and fill have been placed at this site. The slopes were rather steep at approximately 2(H):1(V). They were sparse to heavily revegetated. A sedimentation basin with decant overflow pipe was placed below the fill in order to manage flows and reduce sediments to Greens Creek located nearby. The basin is called “Pond C”. A small flow of water was observed at the toe within the sedimentation basin area.

This area was studied under the March 1995 Kennecott Greens Creek Mine Production Rock Site Characterization Study prepared by KGCMC. The results of one drilling at this site showed the material was carbonate dominated. It had an NP/AP value of 1.48 (i.e. predominantly neutralizing).

Two test pits were dug in 1998 prior to the development of the structures located on top of Site C. Seven samples of ABA analysis and paste pH were taken. Paste pH ranged from 7 to 8 with one sample result of 5.9. NP/AP ranged from 0.2 to 1.8. The average NP/AP ratio was 0.6 (predominantly acid generating).
